DRUM SEARCH

TORCH LAKE DRUM
HOUGHTON, MICHIGAN

FINAL DRAFT REPORT

Roy F. Weston, Inc.

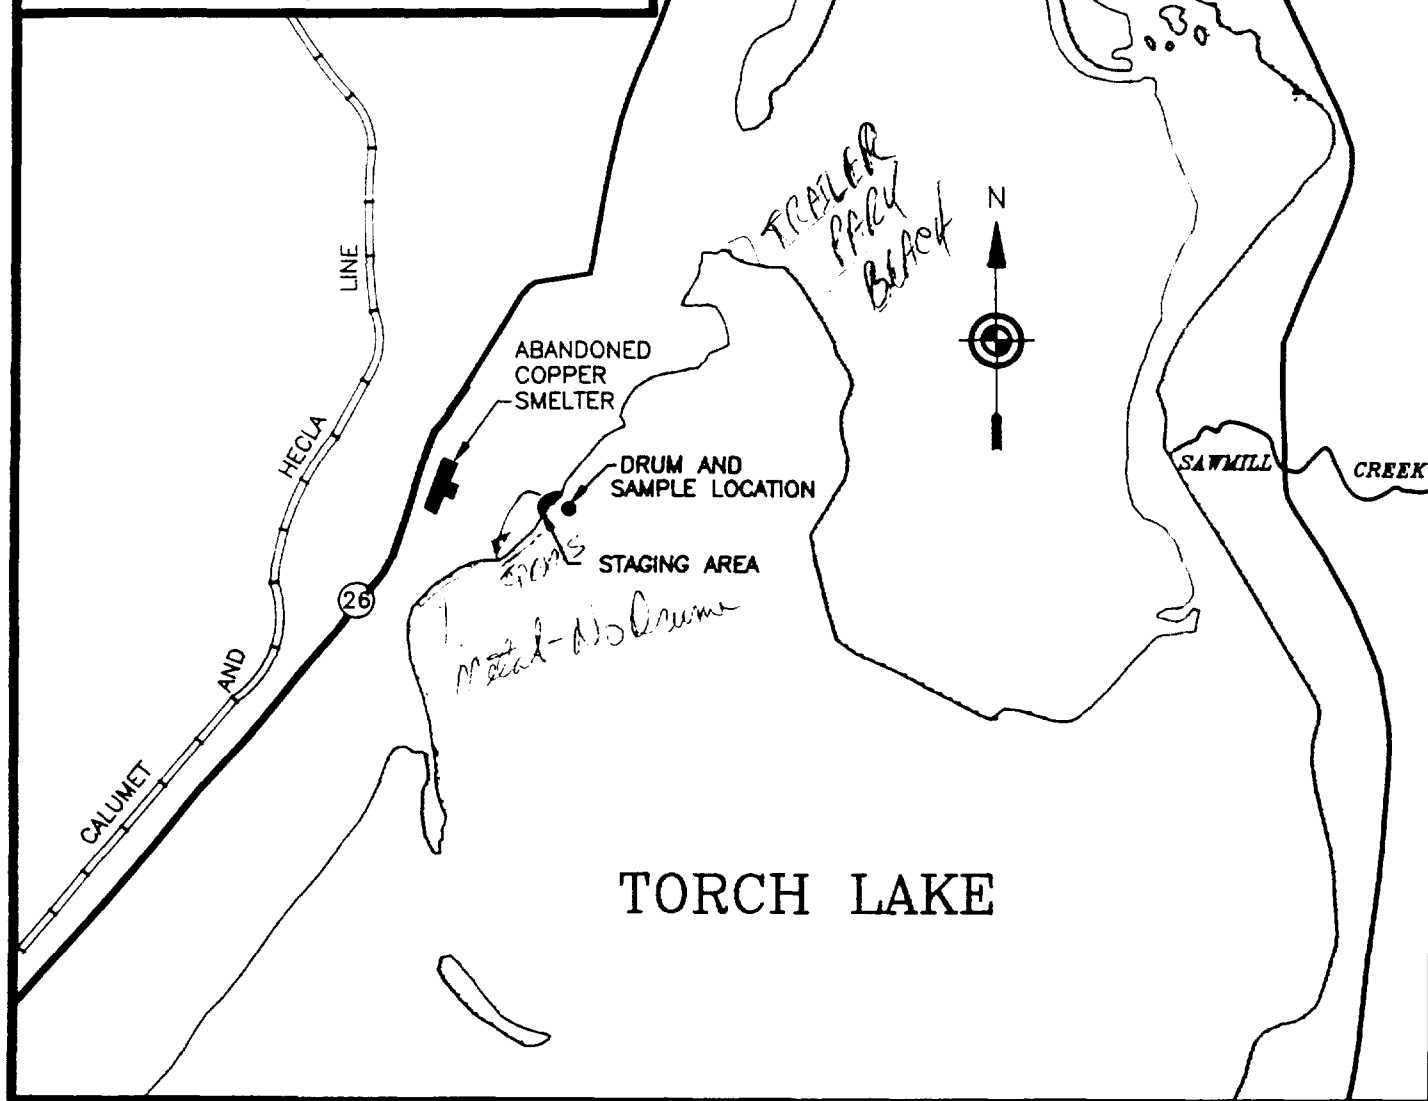
FIGURE 1
TORCH LAKE SITE LOCATION
LAKE LINDEN, MI
AUGUST 3, 1989

All underwater search activities were observed on the video monitor and recorded on video cassette tapes. Ten drums were located and filmed near the staging area (see Figure 1); three were near shore in 6 to 8 feet of water and seven were approximately 50 to 75 feet up the shore to the north in 12 to 20 feet of water. Some of the drums were empty, others had solidified contents. All drums, including weathered drums found
